The Owner's Guide to Piano Repair

Focus On: Replacement of Worn Asian-Design Hammer Butts and Flanges

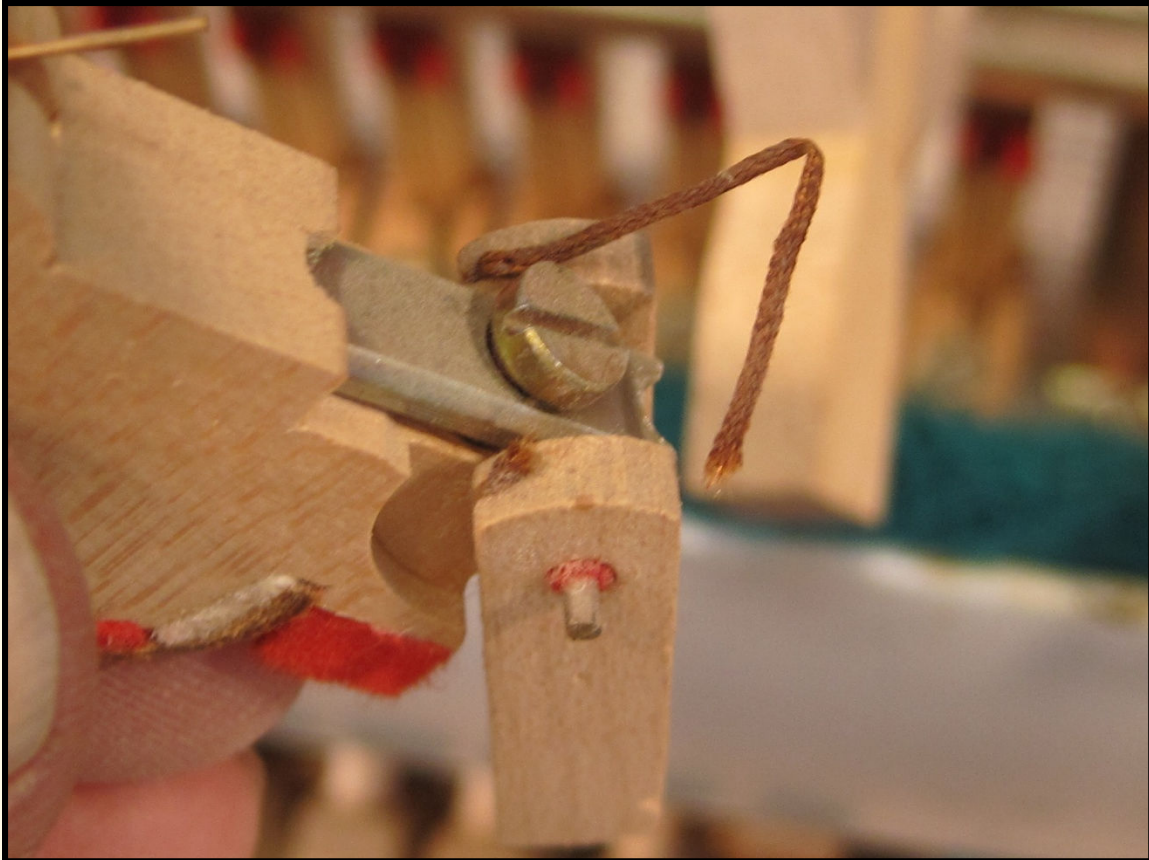
The Achilles heel of Yamaha, Kawai and other Asian-made pianos is a hammer butt assembly that relies upon a small braided cord to hold an essential spring in check. After years of use this cord is prone to breaking (as shown in photo on cover), which causes the piano action to perform unsatisfactorily.

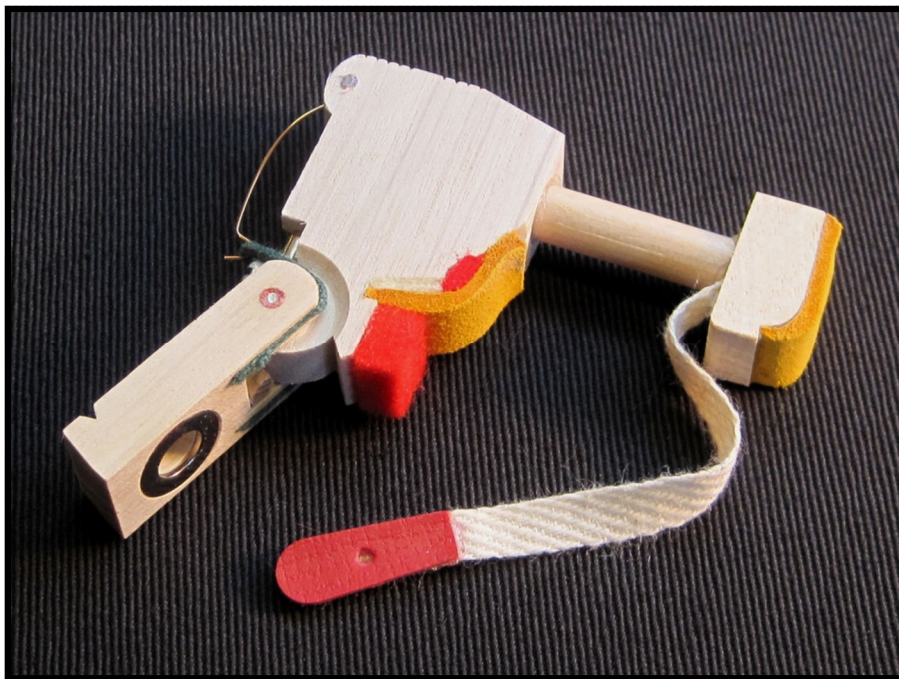
A new Asian-design hammer butt / flange assembly ready to install.

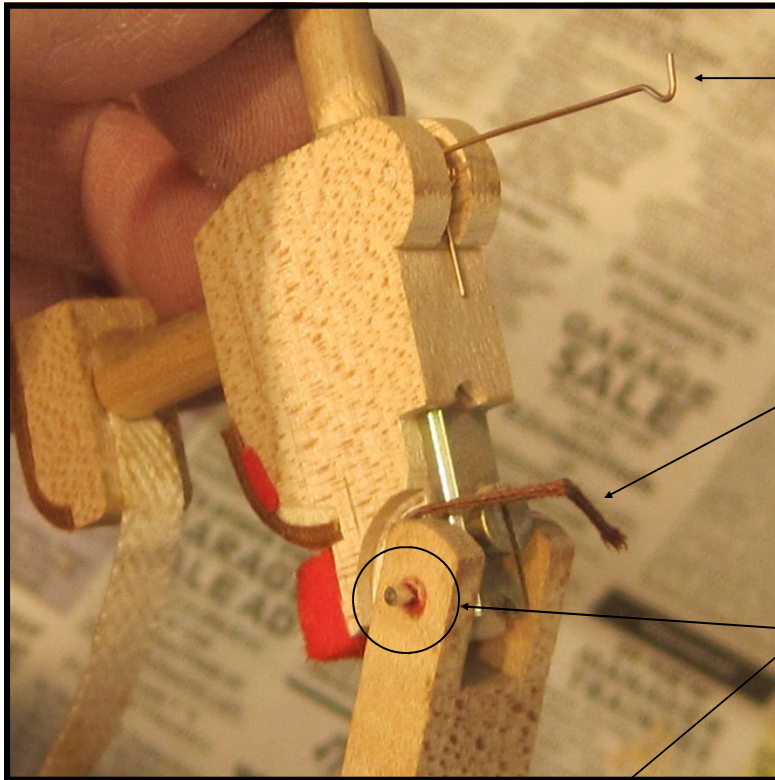
The following photos of used hammer butt / flange assemblies from a 1980s Yamaha studio upright illustrate the most common problem areas.

Hammer butt return spring: When held in check by the flange cord, this spring swiftly returns the hammer butt to its rest position so that it's ready to fire again the next time the note is played.

Flange cord: Although strong enough to hold the continuous tension of the return spring for decades, it eventually can give out and break.

Action center: The pivot point for the hammer butt. As the felt bushing and brass pin become worn, the fit of the pin loosens, causing sloppy play. The pins in the photos have worked loose entirely from one side of the flange, causing extreme wobble.

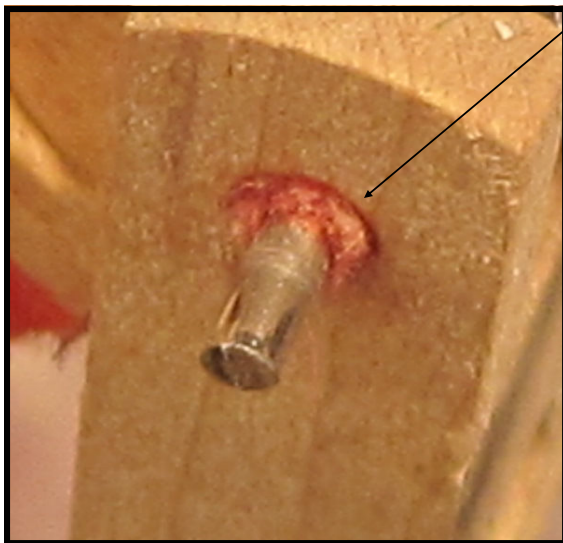
Although less obvious than broken flange cords, loose action centers also cause problems for the performance of the piano. Ordinarily, wear and tear of the felt bushing is the cause of overly loose action centers, but sometimes the brass pins themselves begin to wear away, as in the photo to the left. When an action center has thus loosened up, hammers wobble on their way up to the strings, striking less than a solid blow. In extreme cases, hammers may go off course to the point where they hit the wrong strings!

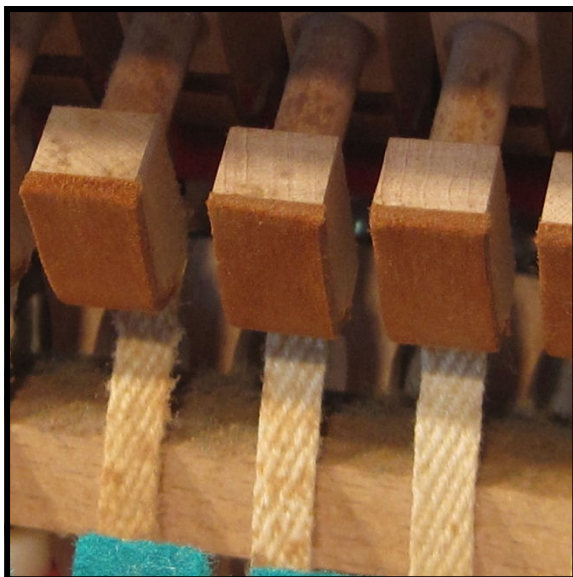
Old hammer butts

Consider the above photos showing a part called the catcher, which is faced with a buckskin (or similar) covering. When a note is played, this part is essential to preventing repeated strikes (called "bobbling" notes). The buckskin surface wears thin over the years, especially on portions of the keyboard which are played more heavily. In the photo on the left showing a set of original hammer butts, the buckskin covering the center catcher has worn thinner than the two adjoining catchers. The photo on the right shows the new catchers of replacement hammer butts. Not only is the buckskin covering uniform in thickness, providing a consistent cushion to the parts coming together, but it has a better ability to make a secure contact with the backchecks (the thick green felts at the bottom of the photo). The rougher texture of the new buckskin will grab the backchecks without slipping, as older, worn buckskin is prone to do.

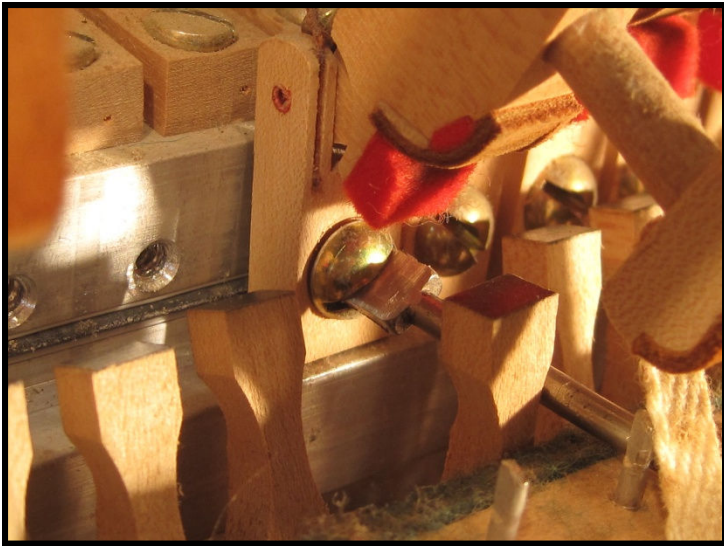
The first step is to remove the original hammer butt / flange assemblies from the piano action. These are taken from the action by carefully unhooking the bridle straps, then backing out the flange screws holding each assembly in place so that each unit may be lifted out.

Since extensive disassembly is required, care is taken to make sure that parts go back together properly. When a section of hammer butt / flange assemblies is removed, for example, key assemblies are left in place to line up the parts as they are returned to the action.

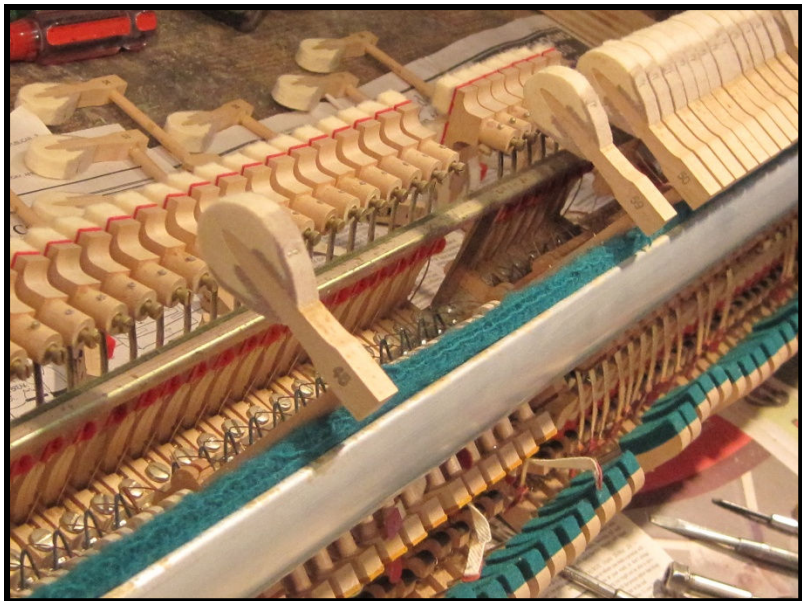
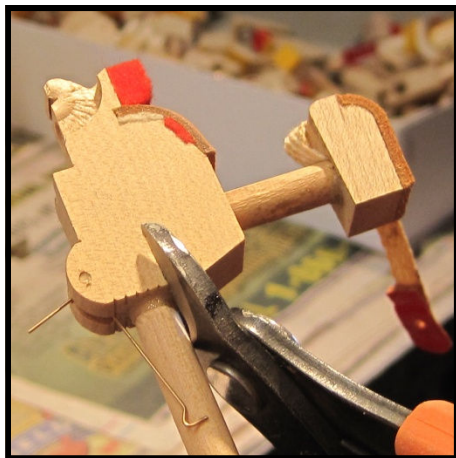
The old hammer butts are then removed from the hammer shanks, usually by using a pair cutters to cut along the grainline. Several cuts are required to remove the old part, at which time the shank needs to be cleaned of any remaining wood and glue.

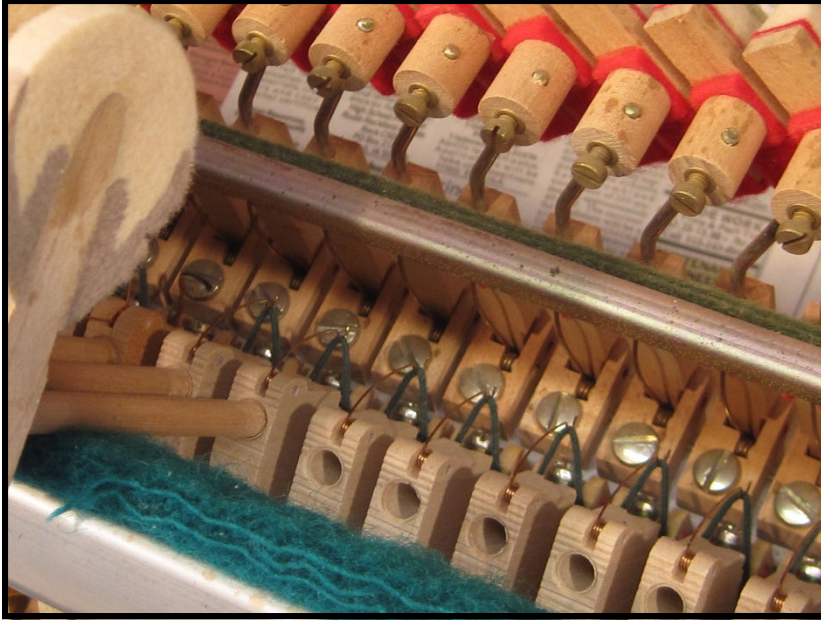
The hammer shanks are then dry fitted into the new hammer butt assemblies. With all the hammers in place, careful alignment will be done, and only then will the parts be glued together.

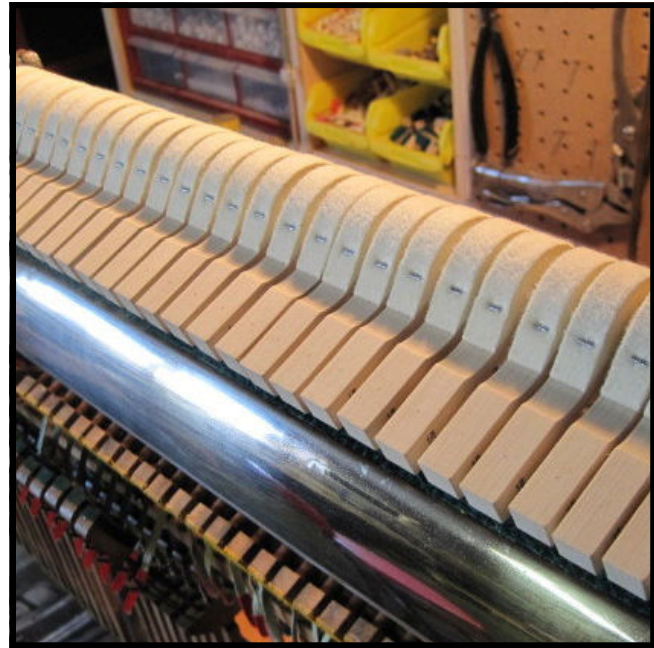
For the best results, worn hammers must be either shaped or replaced. Old hammers have often been badly cut into by the strings of the piano, resulting in them having an outer layer of felt which is dead or pulpy. By carefully removing the outermost layer of felt, hammers can be brought back to life. For badly worn hammers, replacement will give the piano a new lease on life. With either hammer reshaping or replacement, time will be needed to voice the hammers for consistent tone.

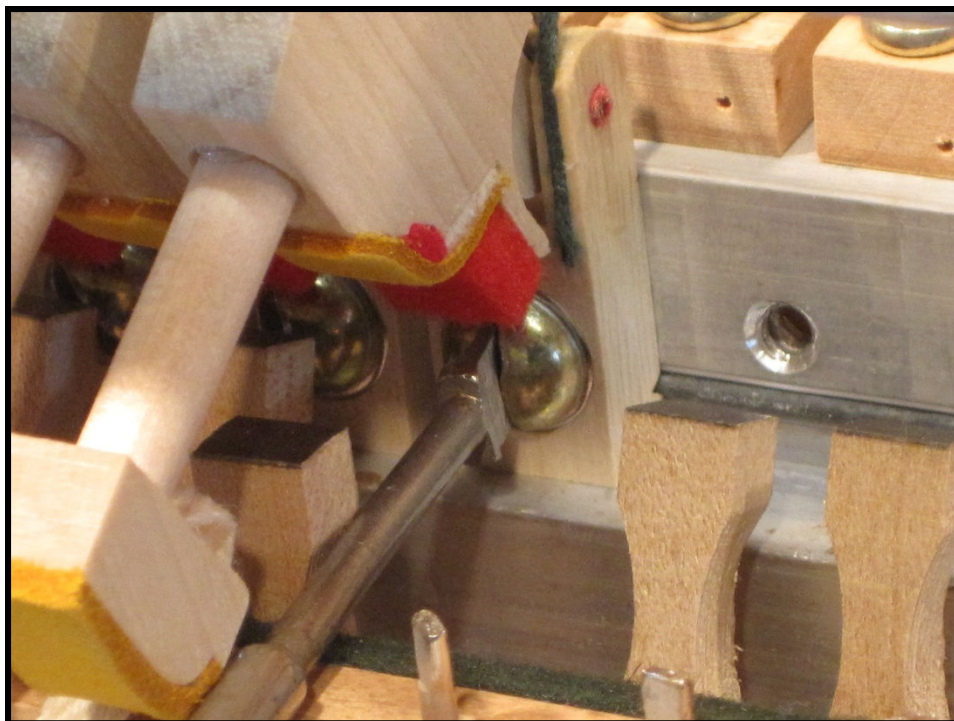
New hammer butt / flange assemblies being installed.
