The Owner's Guide to Piano Repair

Focus On: Plastic Elbow Replacement

New York Piano Works

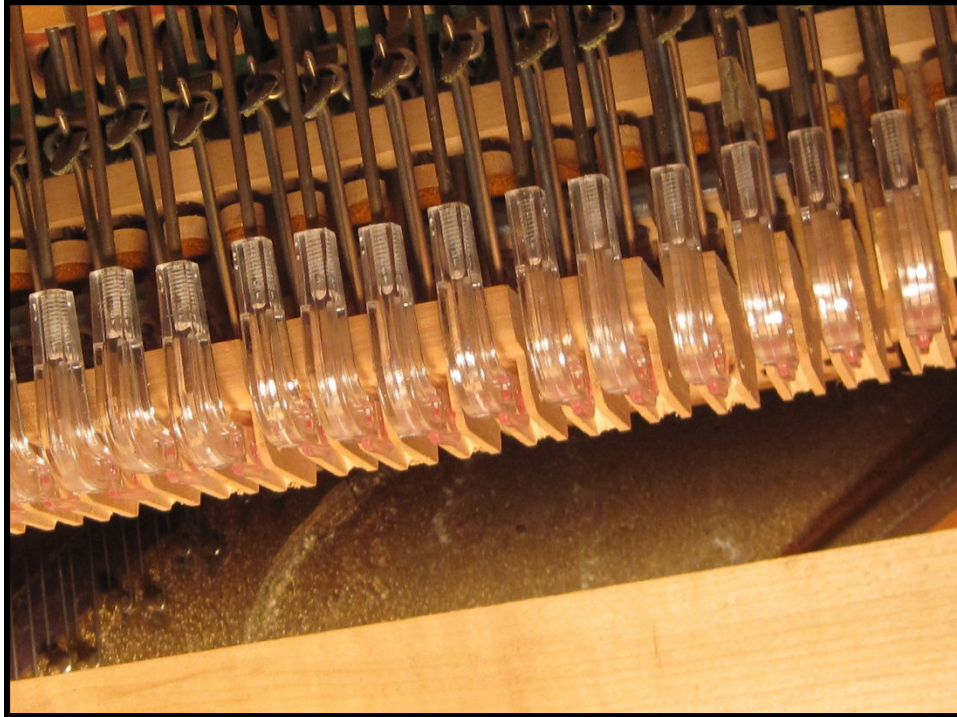
A completed installation of Vagias Snap-On elbows in a spinet piano.

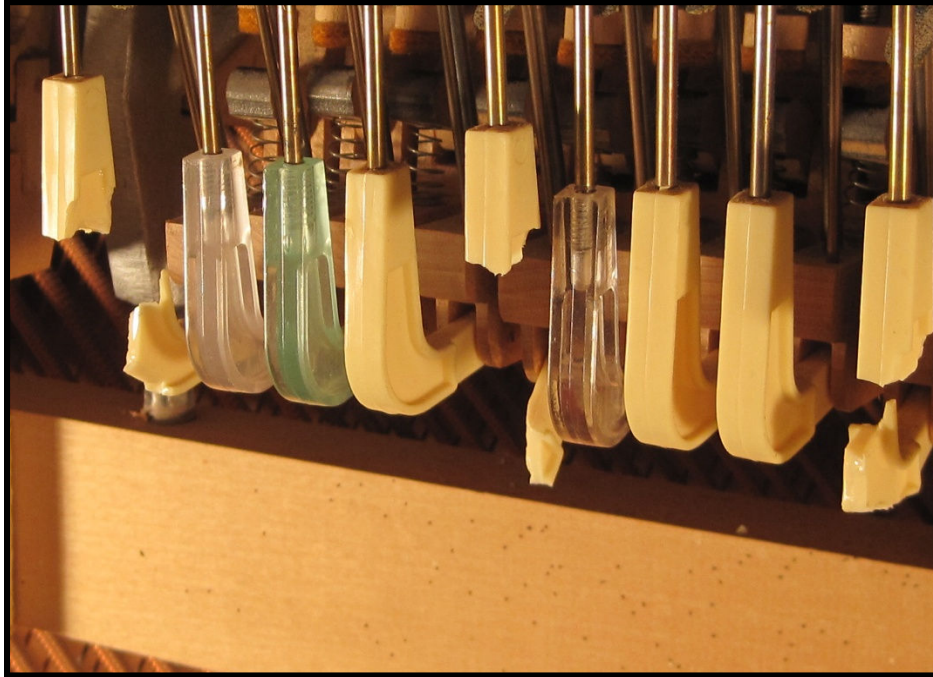
Breakage in progress.

This half-hearted approach is in fact sometimes taken, as shown in the above photo. Three broken elbows here need to be replaced (along with six more not visible in from this camera angle). In between the broken elbows may be seen three replacement elbows, *which were replaced on three separate occasions*. Thus, the owner of this piano had to put up with broken notes time and time again, until she finally decided that enough was enough, and the repair was done correctly.

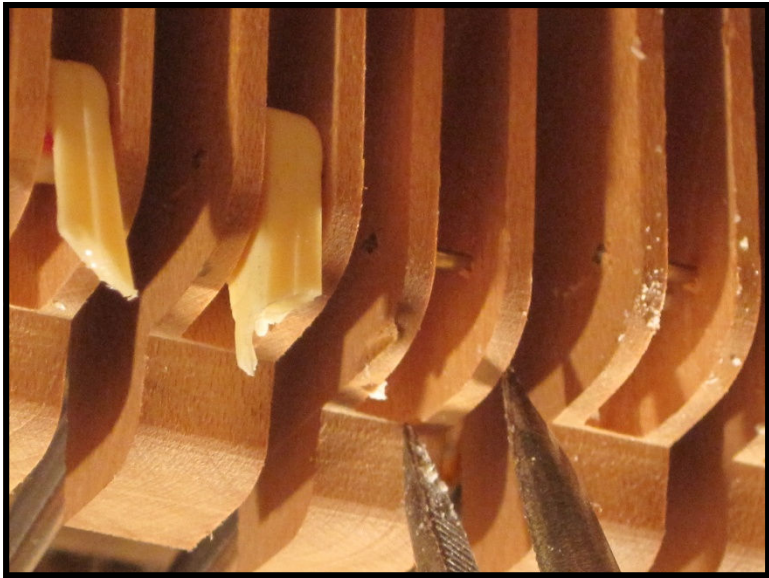
The first step is to intentionally break each elbow off close to the wooden wippen, the part in the lower area of the piano action which the elbow connects to. The old elbows were connected to the wippen with a brass pin, which the new Snap-On elbows will be also connected to. Before that may be done, however, the remaining portion of the old elbow must be carefully broken away and removed from the wippen.

This is a delicate step and one that calls for an experienced hand. If too much pressure is applied in breaking away the remnants of the old elbows, the thin wooden wings on either side of the slot in the wippen may be easily broken. If this happens, it greatly compounds the amount of work

which needs to be done. Fixing broken wippens is a more serious problem, often requiring the removal of the action from the piano.

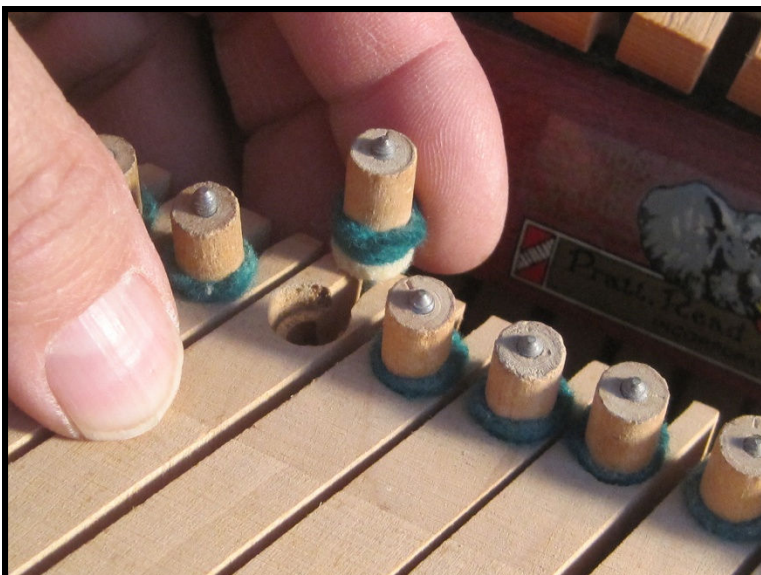
There is, however, one easy related repair that you should be able to fix on your own. At times a note that is dropped down in front is not the result of a broken elbow at all, but is simply an unattached wooden button at the back of the key. To check, open the lid of the piano, pull the key cover forward a bit, and look to see if any buttons have come loose, as shown. Fix by returning the button back into place in the recessed slot. Push down firmly.

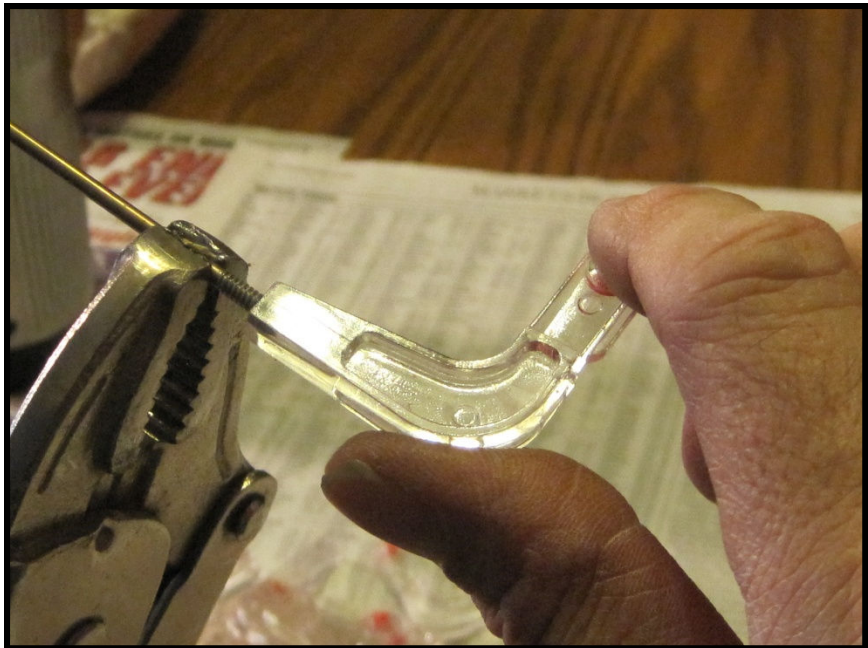
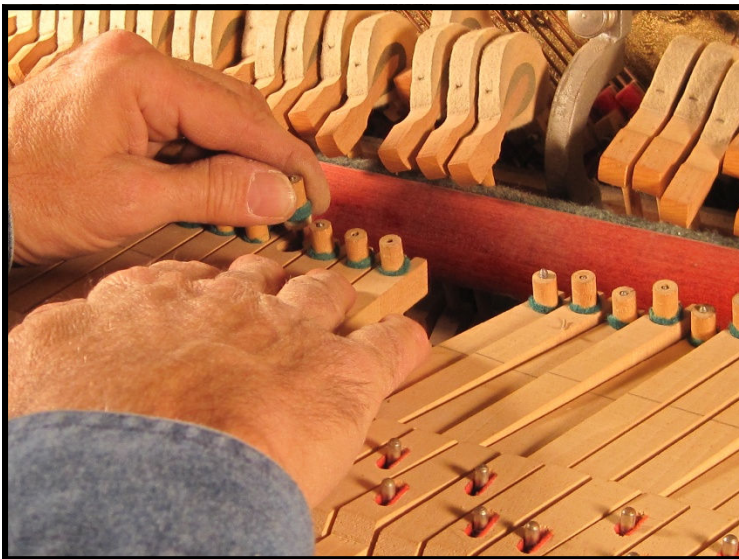
After the remnants of the old plastic elbows are broken away from the lifter wires, the new Snap-On elbows are individually screwed onto the threaded lifter wires to an exact depth. The lifter wires with the new elbows attached are then reinstalled in the piano. Working from underneath the keybed, the buttons are positioned in the slot at the back of the keys, and the new elbows are firmly snapped into place on the brass center pins of the wippen.

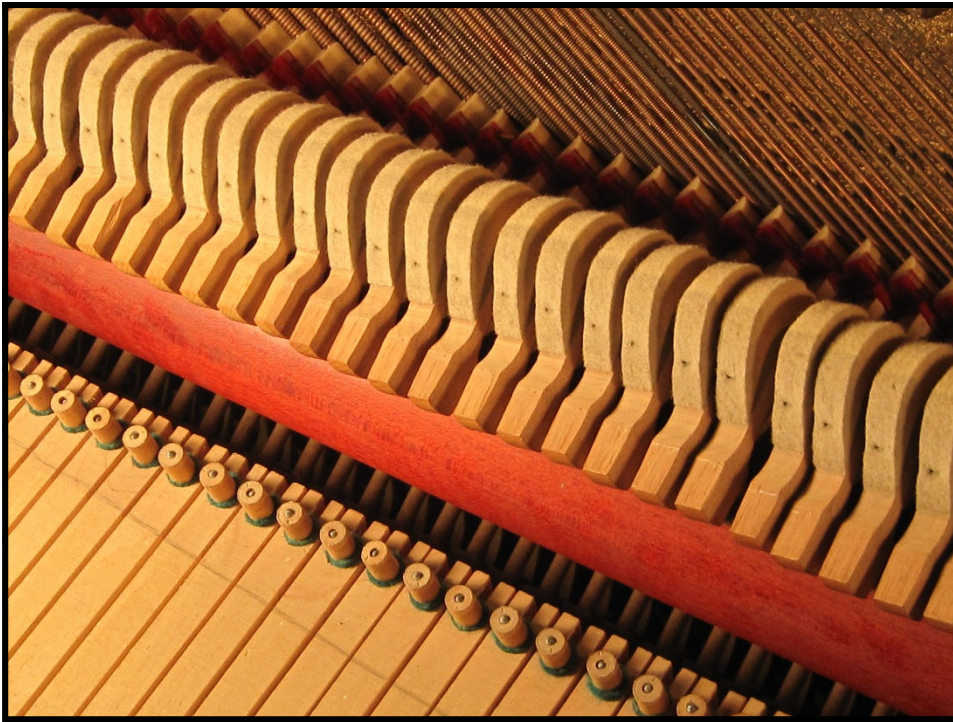
With new elbows installed, and regulating buttons adjusted, all hammers are ready to fire.

Yes. Once the lifter wires with attached elbows have been installed, adjustments will need to be made to the amount of 'lost motion' that each note is given to prevent hammers from either bubbling (striking the strings more than once) or from blocking up against the springs (hitting the strings before being released).
