The Owner's Guide to Piano Repair

Focus On: Replacing Upright Hammer Butt Springs

New York Piano Works

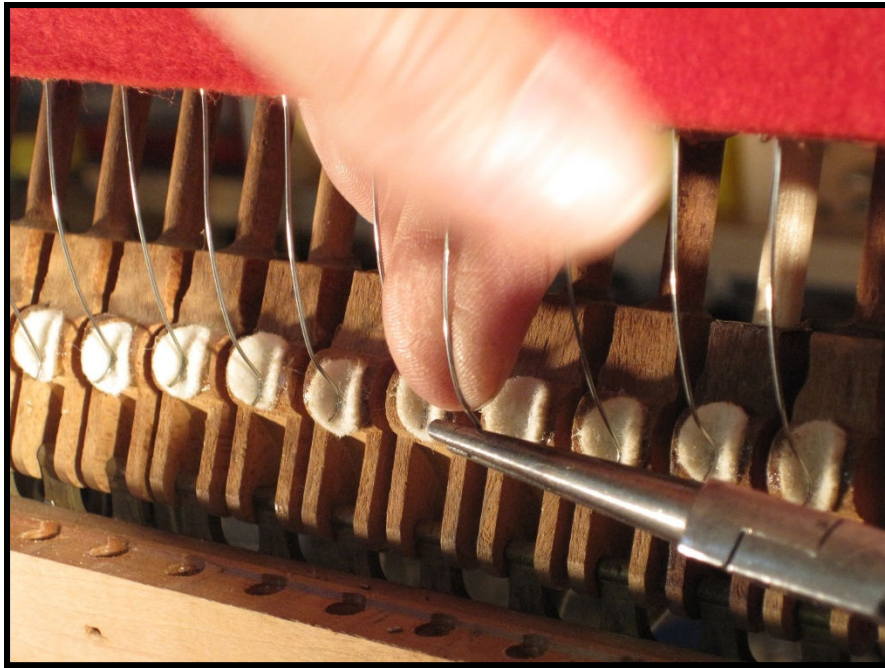
A new set of original-type springs being given final adjustments in the action.

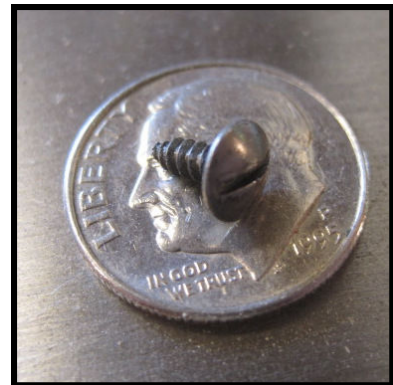
The screw supplied for the repair clip is tiny, and even when using a special screw-holder, it can be a challenge to get started. Especially when trying to hold the clip in place with one hand, maneuvering the screw around the hammer rest rail and hammer shanks without the screw popping off the screw holder can be an exercise in frustration.

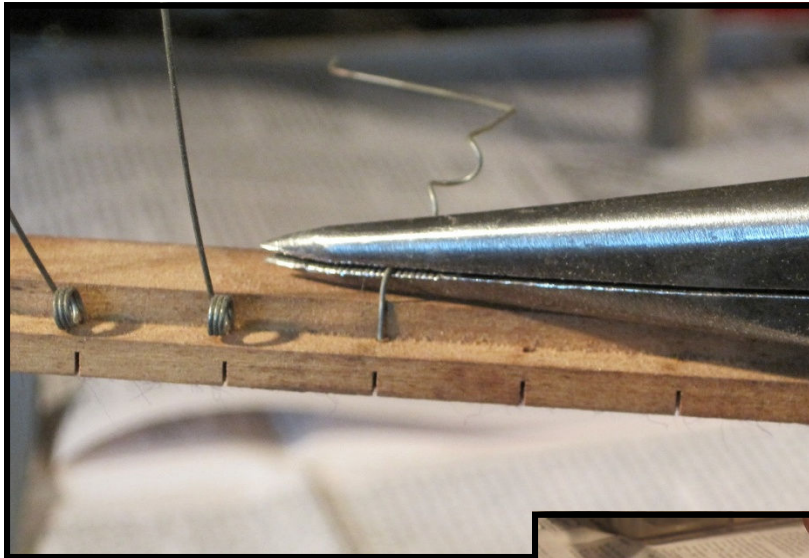
First of all, the hammer butt spring rail is removed from the action. The old springs are then carefully removed by pulling each spring wire free.

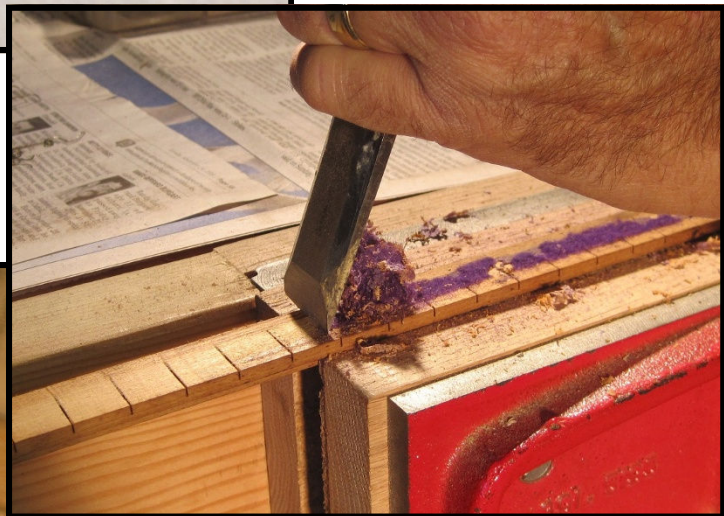
The spring rail felt on the back of the rail is scraped off and will be replaced at a later stage in the process.

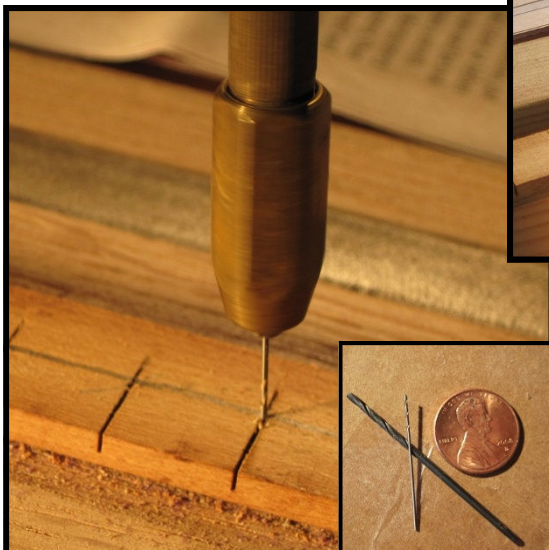
A .025" hole is next drilled in the hammer butt spring rail for the tail of each spring to be inserted through. (The insert shows the size of this drill bit in comparison to a penny, and an ordinary 1/16" bit.)

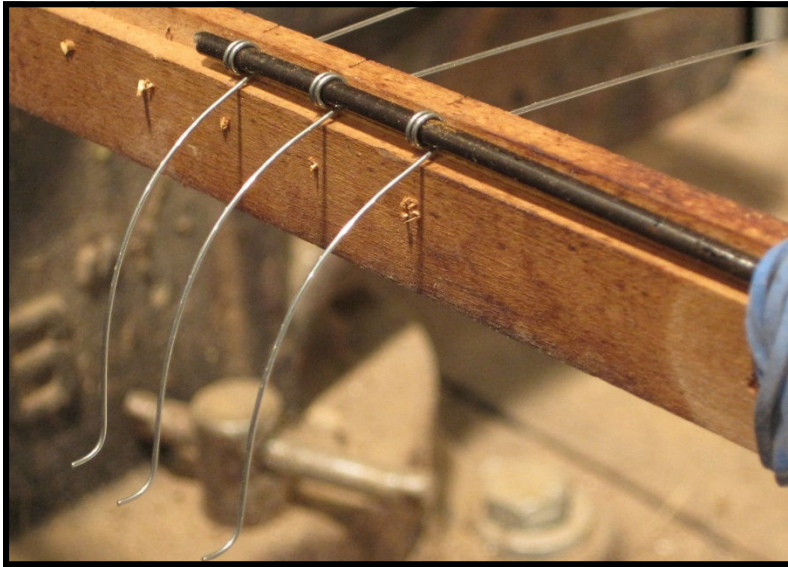
The tail of each new spring is then inserted through the original hole in the rail. (The short sliding wire helps keep the coils of the springs in line while the process is being completed.)

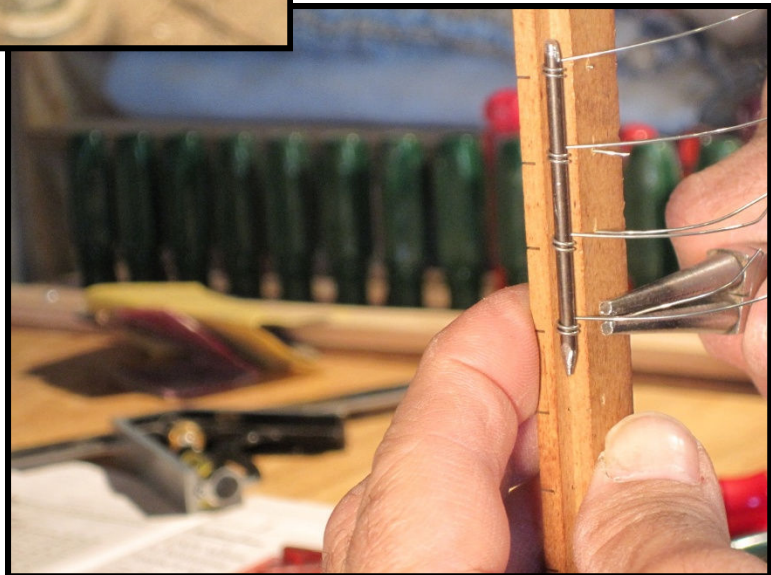
The long tail of each spring is then pulled through the tiny hole which has been drilled. (This step allows the spring metal to be drawn tightly into the slot on the opposite side of the spring rail which the original spring was inserted into at the factory.)

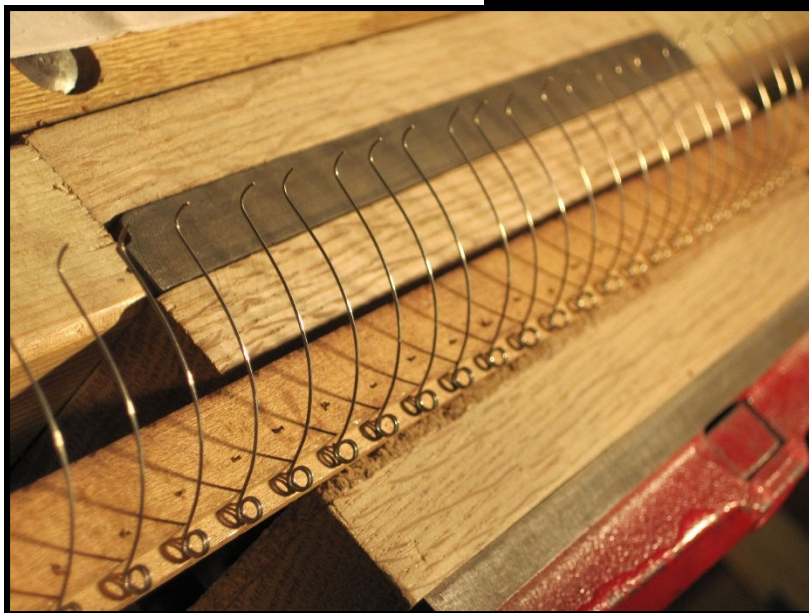
The springs are given fine adjustments while the set is held in place in the vise so that each of the springs lines up perfectly with its neighboring springs. Adjustments from side-to-side, and up and down are required to even out the line.

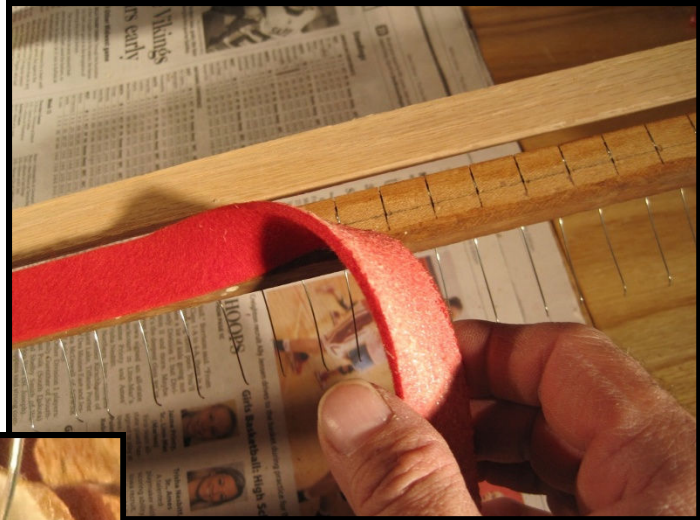
A new length of fresh spring rail felt is now glued to the back of the hammer spring rail. It is essential that this felt be of the correct width and thickness. This felt is clamped in place in a press overnight to ensure adhesion.

When the new set of hammer springs are reinstalled into the action of the piano, final adjustments are often necessary. Here, springs which are just a bit too long are clipped to the correct length, after which a new curved end is formed.

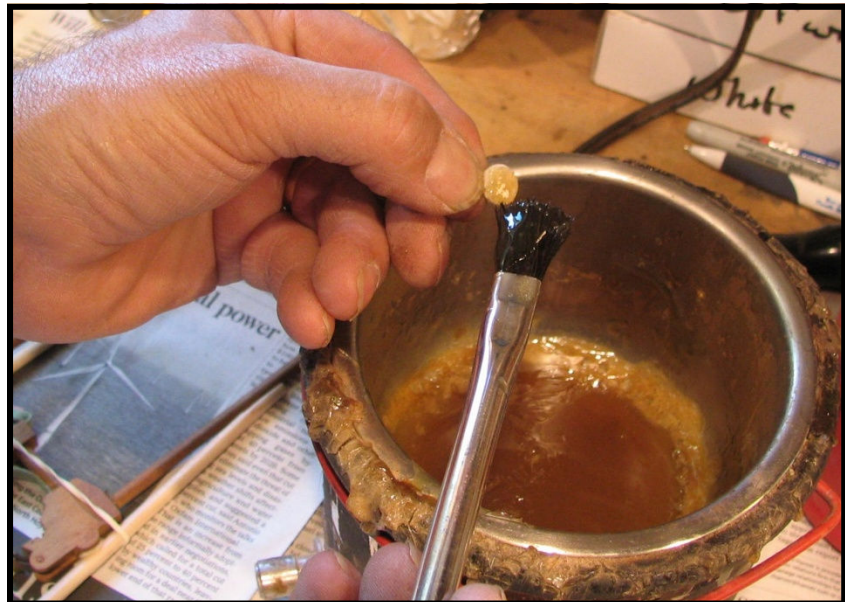
In particular, with a new set of hammer rail springs, it would be highly appropriate to install new felt punchings to line the hammer butt groove that the springs fit into. In the photo, hot hide glue is applied to the back of a felt punching prior to installation.

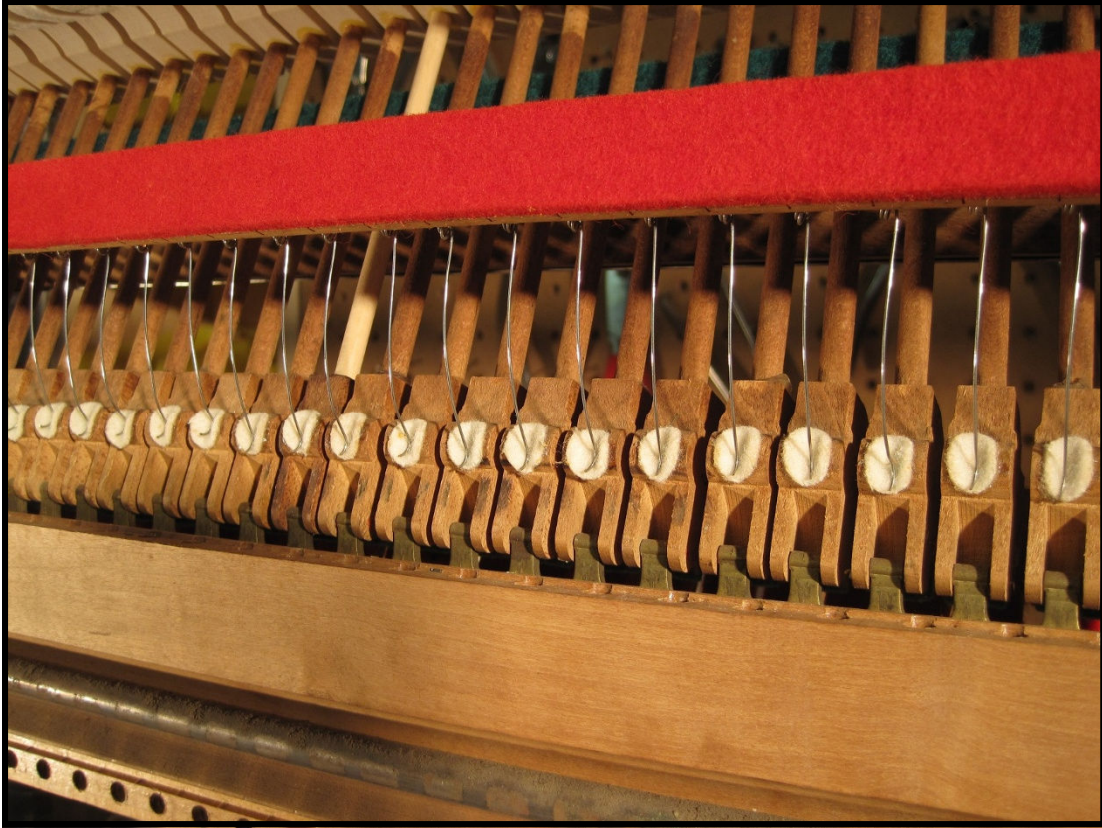
A net set of hammer rail springs helps complete an upright action restoration job.
